Steel Worker Falls from Highway Bridge and Dies

Incident Number: 10KY043 Revised

Kentucky Fatality Assessment and Control Evaluation (FACE) Program

Release Date: November 29, 2011/ March 30, 2012

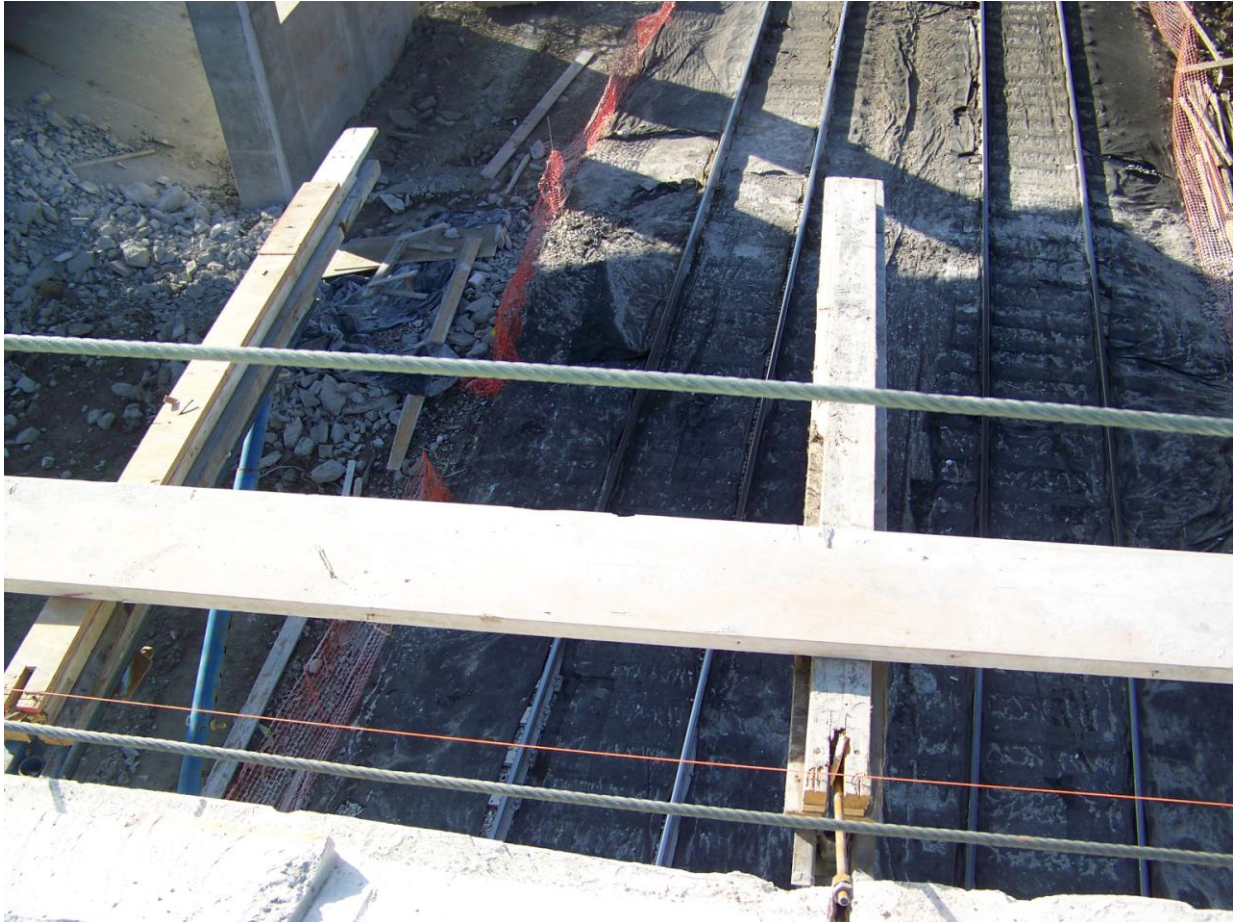
Bridge where worker fell from. Photograph donated by, and property of, Kentucky State Government.

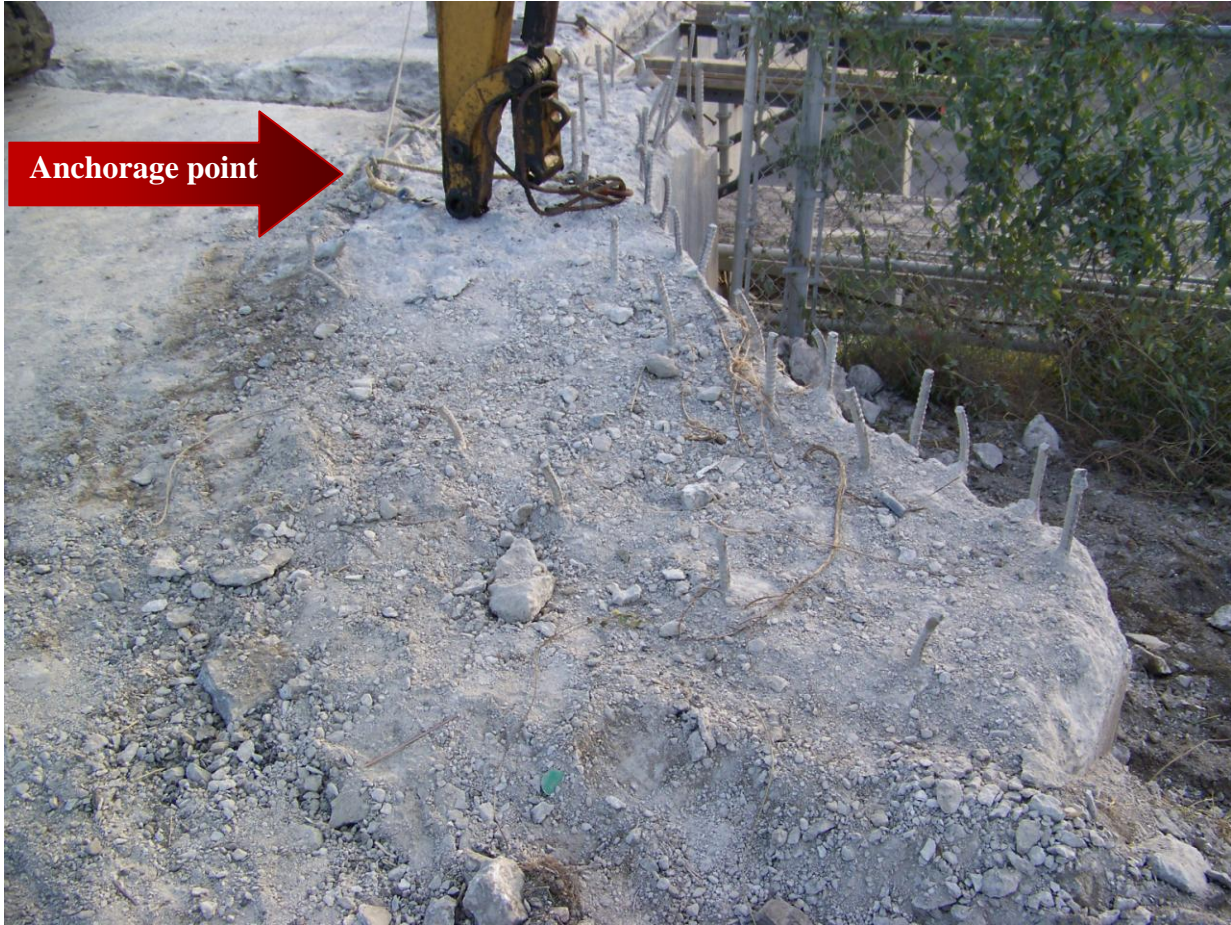
Lifelines should be anchored in such a way as to prevent the lifeline from coming unanchored if a fall should occur and be able to withstand at least 5,400 pound dead weight. Non-continuous strands of lifeline should be properly attached to each other. The lifeline used in this instance was non-continuous and improperly anchored.

Anchorage point at west end of bridge. Photograph donated by, and property of, Kentucky State Government.

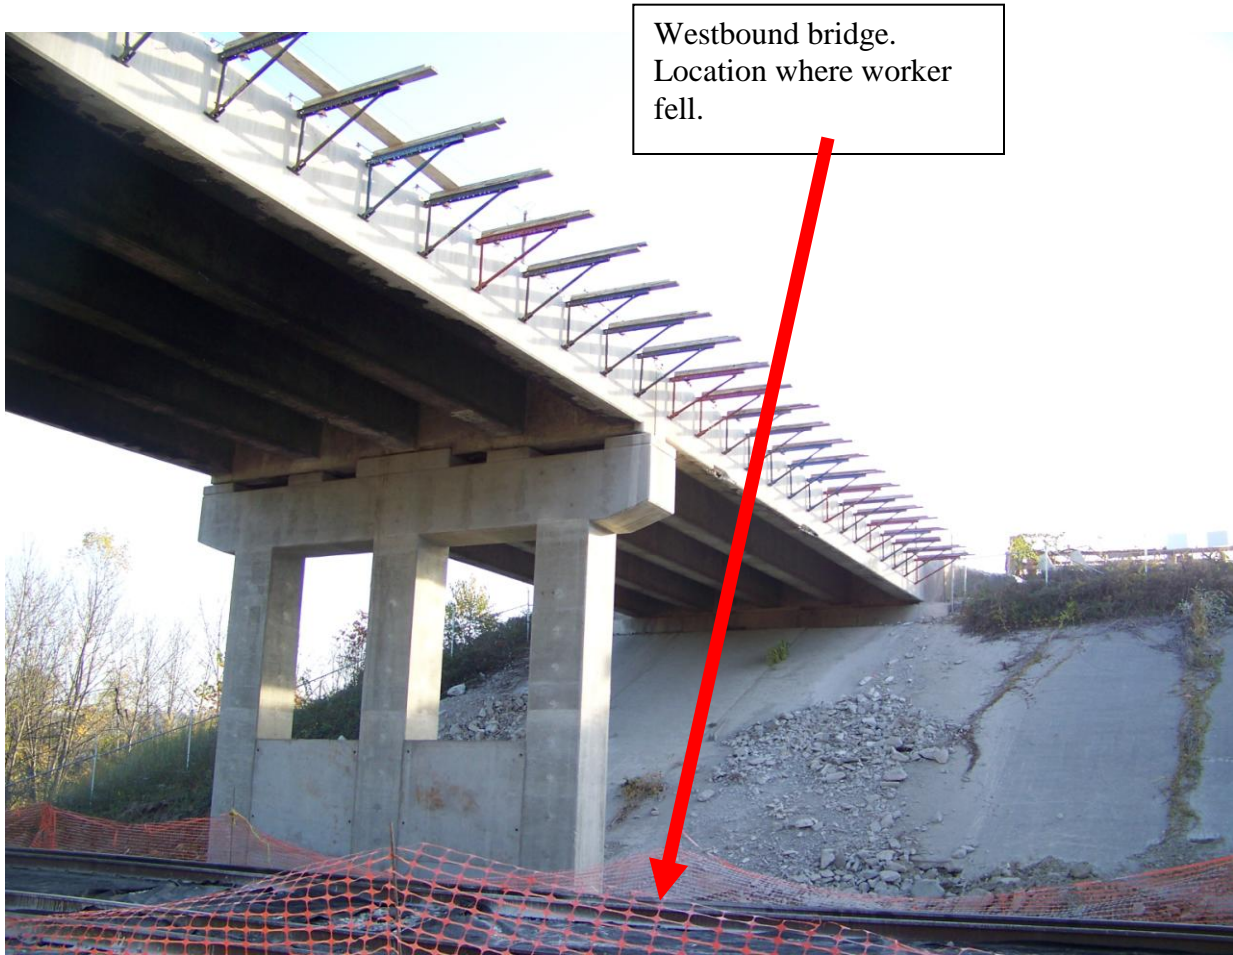
Westbound bridge.
Location where worker
fell.

Bridge that worker fell from. Photograph donated by, and property of, Kentucky State Government.
