**SUBJECT:** A Roofing Supervisor Dies When He Falls Through a Skylight

**SUMMARY**  
**California FACE Report #11CA004**

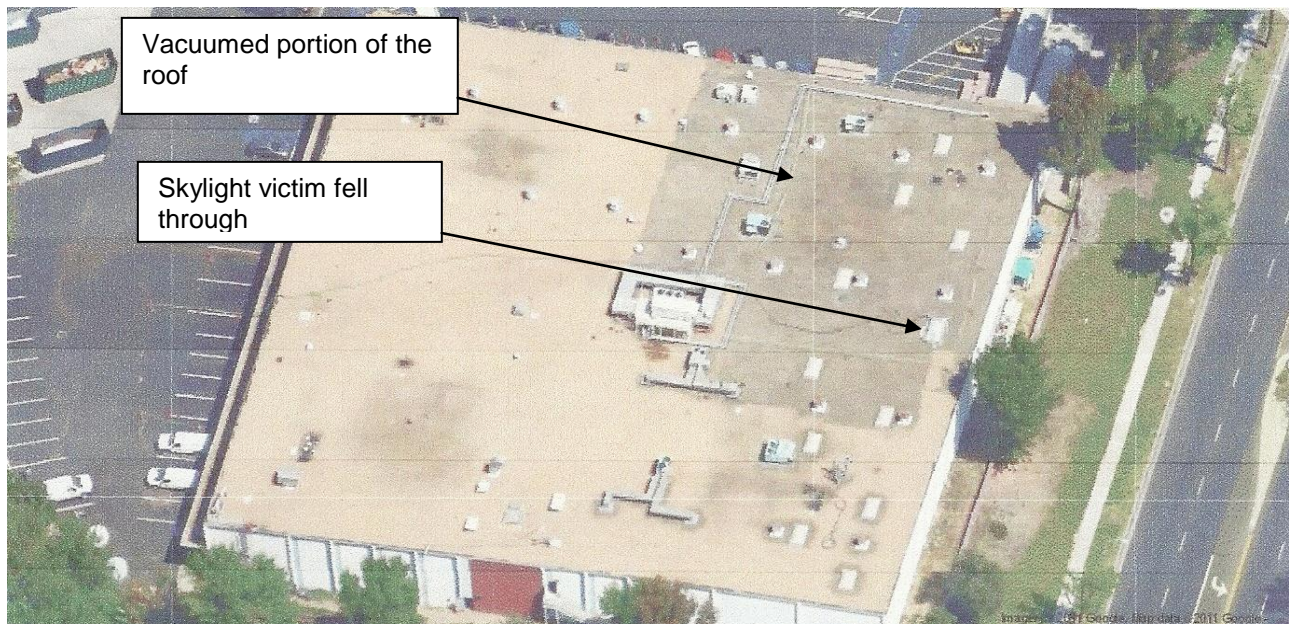
The location of the incident was a large industrial flat roof of a warehouse that measured approximately 150 feet long and 150 feet wide (**Exhibit 1**). The roof housed many air conditioning units, skylights, vents, and other plumbing and electrical fixtures.

**Exhibit 1. The warehouse rooftop where the incident occurred showing the vacuumed portion of the roof.**

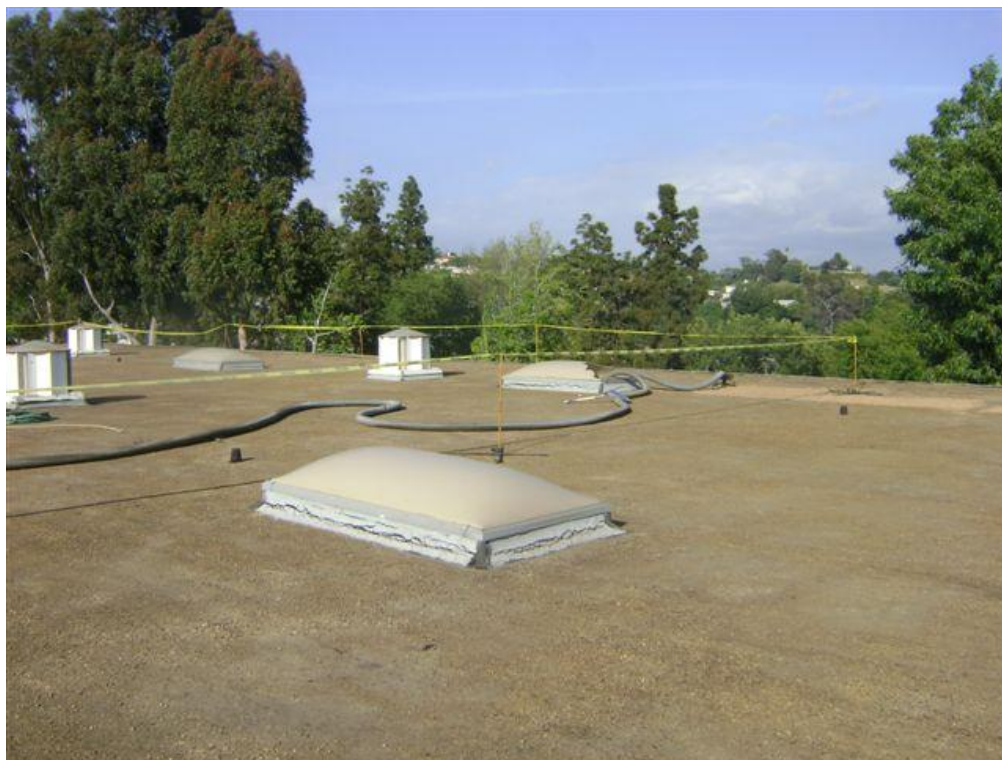
**Exhibit 2. The work area on the roof.**

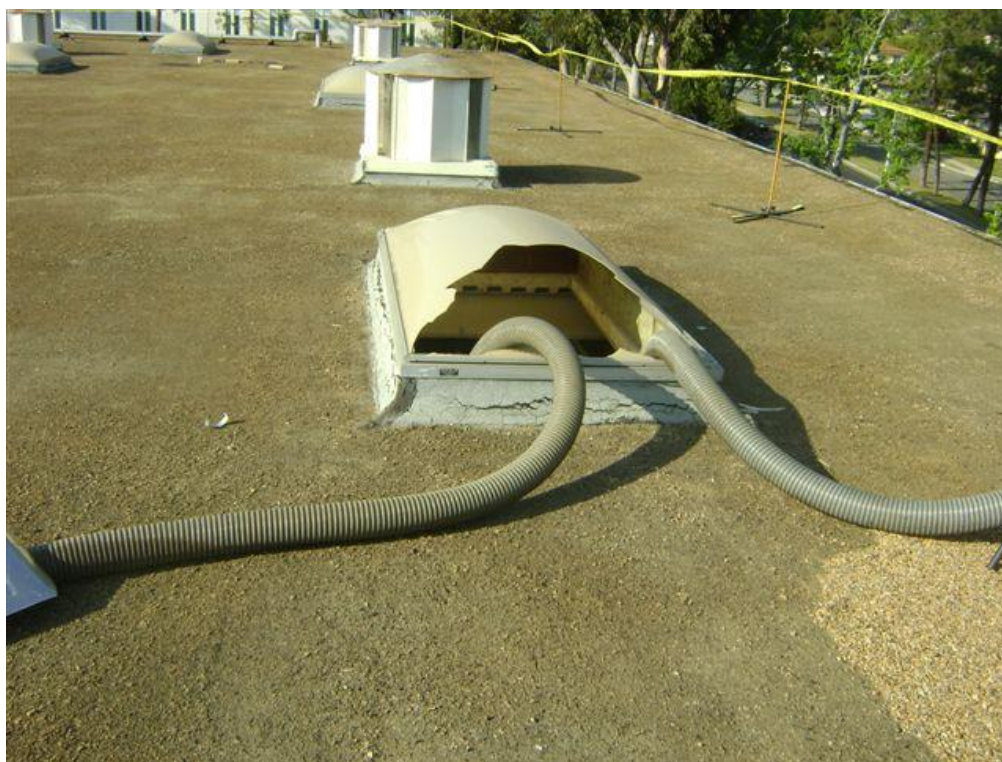
- The victim was working within six feet of an unguarded skylight.

Discussion: In this incident, the victim was trying to prevent worker #2 from tripping and falling, by moving the vacuum hose out of his way. When he moved the vacuum hose he either tripped or lost his balance and fell through the skylight. Most skylights should be considered a “roof opening” and a risk for serious injury and death if workers should trip, fall, and break through. Therefore, in order to prevent falls through skylights, employers should implement and maintain a fall protection program that includes any one of the following:

**Exhibit 3. The skylight the victim fell through.**

**Recommendation #1: Fall protection measures such as skylight screens or covers, guardrails, or a personal fall protection system are used for employees working within 6 feet of a skylight.**

- Skylight screens or covers capable of withstanding the impact of a worker plus the weight of his/her equipment.
- Guardrails around the skylight with a top and midrail and a vertical height within the range of 42 inches to 45 inches from the upper surface of the top rail to the floor. The rails should be able to withstand a live load of 20 pounds per linear foot applied either horizontally or vertically downward at the top rail.
- A personal fall protection system consisting of a body harness, lanyard, connectors, and anchor points.

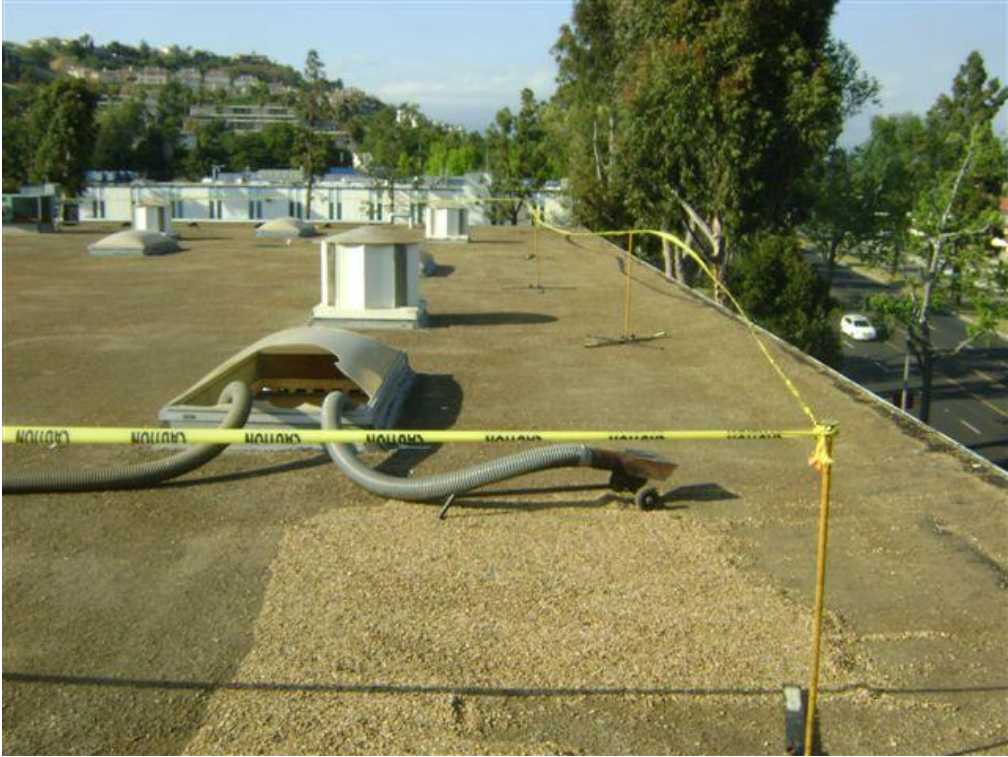
The day before the incident, the victim held a tailgate safety meeting describing the job, duties of the crew, and worker safety. The workers were instructed in skylight safety and fall protection. Instead of an approved warning line, caution tape was placed around a portion of the perimeter of the roof to warn workers of the edge. The work began by using the vacuum with a six-inch diameter flexible hose used especially for rock and gravel removal from roofs. Sometime after 1 p.m., one of the workers (worker #1) moved out of the vacuuming area into another more distant area of the worksite, out of visual and audible contact with the victim and the other worker (worker #2). Worker #2 was operating the vacuum nozzle and the victim was guiding the hose behind him. At this time, the victim probably noticed that the vacuum hose was accumulating behind worker #2 and decided to move it out of the way. When the victim picked up the active vacuum hose, he may have been walking backwards and tripped on the base of the skylight, or lost his balance. He then fell through the skylight to the floor 30 feet below. Worker #2 heard an unusual noise and saw the vacuum hose protruding from the

broken skylight. He saw the victim on the floor below and notified worker #1. The paramedics and fire department were called and transported the victim to the local hospital where he died from his injuries.

**Exhibit 4. The incident scene.**

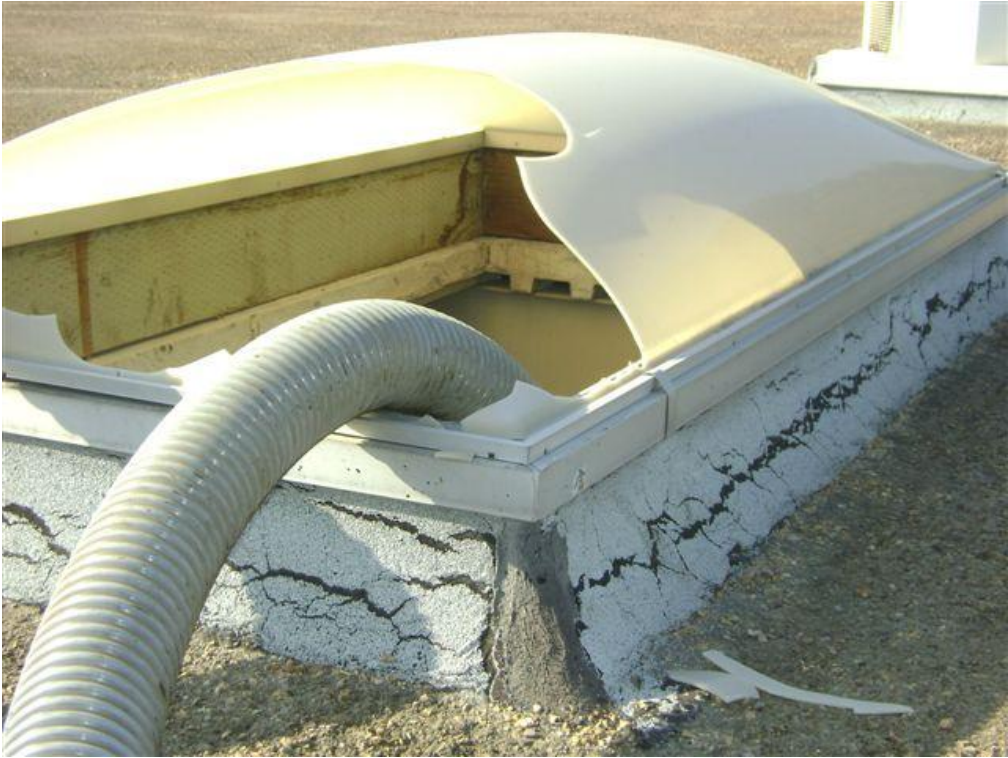
**Exhibit 5. The base of the skylight.**

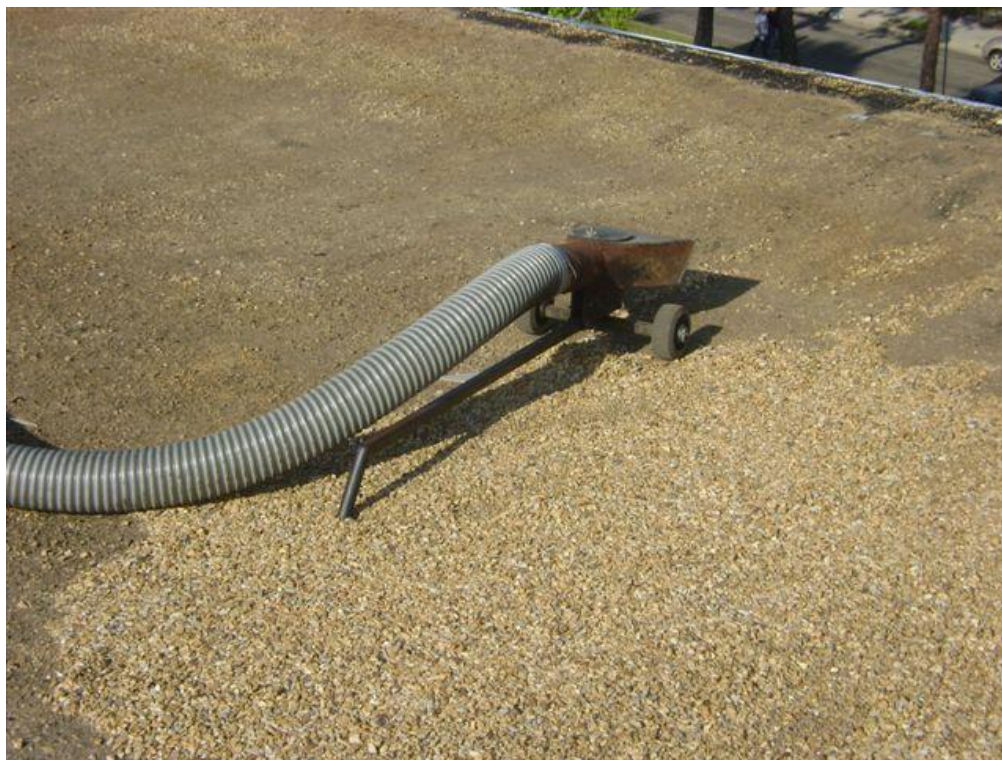
This was the second day on the job for this crew. The job was to perform major repairs to the warehouse roof. The first stage was to remove the crushed rock used to cover the roof. This was accomplished by using a truck-mounted industrial vacuum with a six-inch diameter flexible hose used especially for rock and gravel removal from roofs. The truck was parked next to the building and the vacuum hose was stretched from the truck to the roof. The job was a three-person task with one worker operating the vacuum nozzle, a second worker guiding the hose behind the nozzle operator, and the third worker performing various ancillary tasks.

**Exhibit 6. The vacuum nozzle.**
